REPORT NO. 3692
GULF, COLORADO AND SANTA FE RAILWAY COMPANY
IN RE ACCIDENT
NEAR GAINESVILLE, TEX., ON
JUNE 16, 1956

Accident near Gainesville, Tex., on June 16, 1956, caused by a cut of cars moving out of control on a descending grade as a result of an insufficient number of hand brakes being applied.

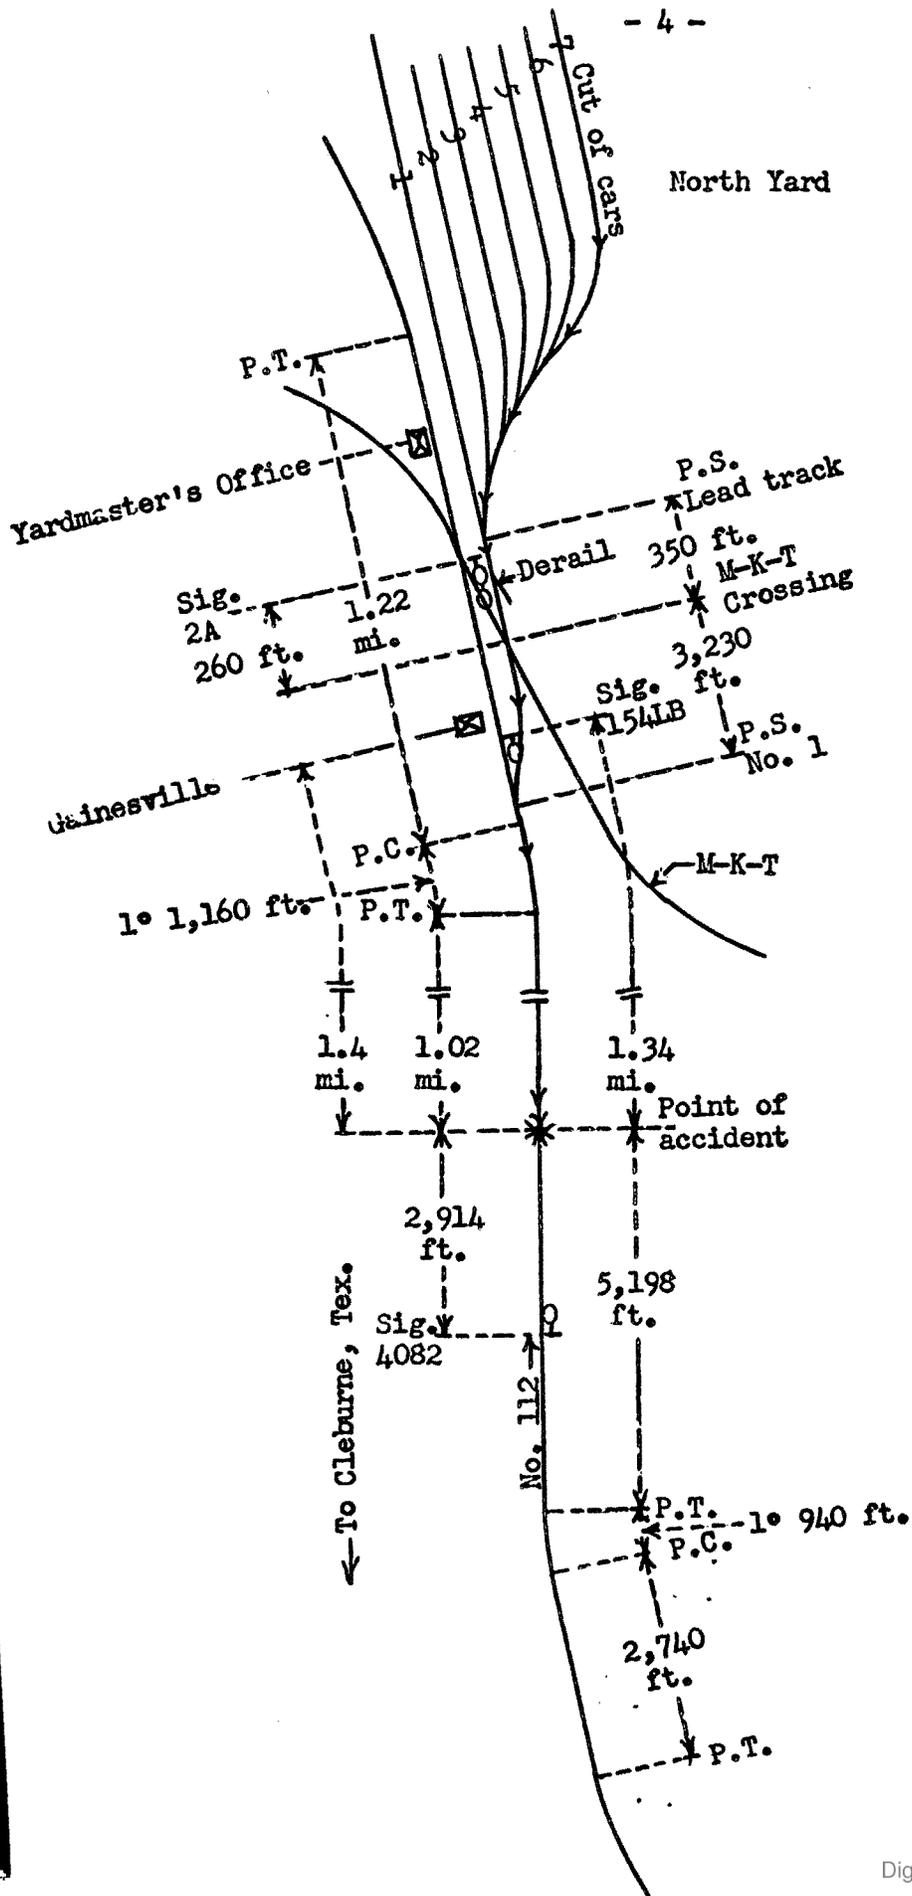
Report No. 3692
 Gulf, Colorado and Santa Fe Railway
 Near Gainesville, Tex.
 June 16, 1956

○	North Yard, Tex.	0.1 mi.
○	M-K-T Crossing	0.5 mi.
○	Gainesville	1.4 mi.
✱	Point of accident	8.5 mi.
○	Valley View	14.0 mi.
○	Dalton Jct.	40.8 mi.
○	Fort Worth	28.5 mi.
○	Cleburne, Tex.

Automatic signal 4082, governing north-bound movements on the main track, and semi-automatic signal 154LB, governing south-bound movements from track No. 1 to the main track, are located, respectively, 2,914 feet south and 1.34 miles north of the point of accident. These signals form part of a traffic-control system which extends between Dalton Jct., 24.5 miles south of North Yard, and North Yard. The controlling circuits are so arranged that when a south-bound movement passes signal 154LB all opposing signals between that signal and Valley View, 9.9 miles south of Gainesville, are caused to display their most restrictive aspects.
